# St. Mary's River Stream Corridor Assessment and Tidal Shoreline Survey

**Robert W. Paul, Ph.D.**  
**Department of Biology**  
**St. Mary's College of Maryland**  
**St. Mary's City, MD 20686**  
**In Partnership with**  
**St. Mary's River Watershed Association, Inc.**  
**PO Box 94, St. Mary's City, MD 20686**

**September 30, 2008**

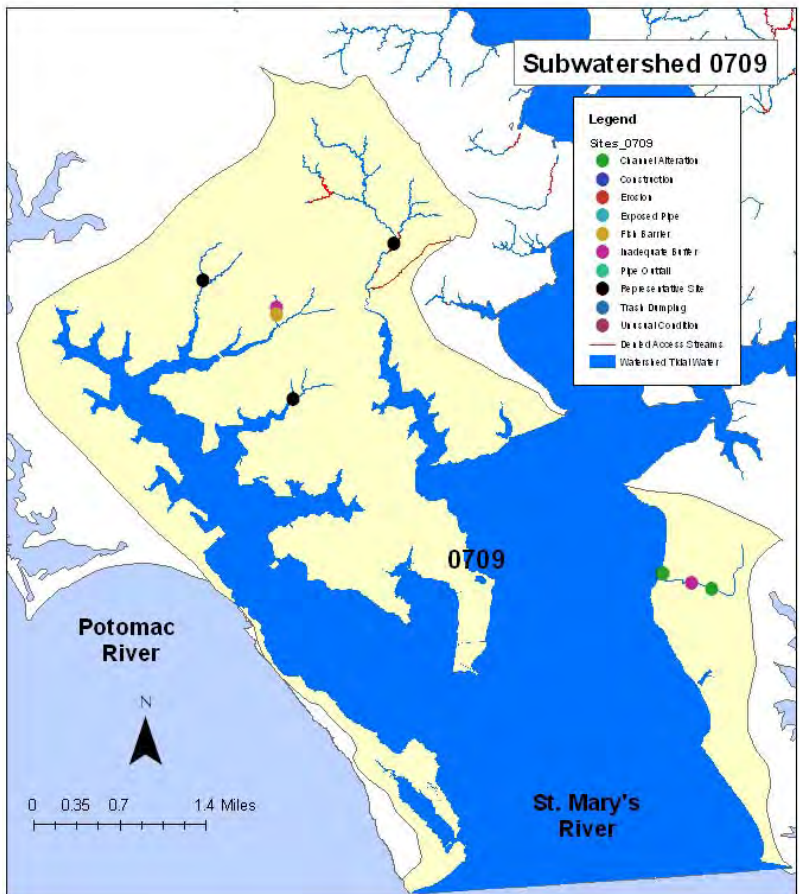
While the lower St. Mary’s River contains only 6.3% of the total watershed stream miles, the subwatershed has a large land area (Figure 4). Most of the streams in this subwatershed are short, low elevation gradient streams that discharge directly into the St. Mary’s River. The subwatershed has 19 first order streams, 6 second order streams, and 1 third order stream. The topography is flat and low elevation gradients do not create erosion problems, so subwatershed 709 is one of 4 subwatersheds without erosion problems. Relative to its large land area, it has few problems: 2 each channel alterations and inadequate buffers, plus one fish blockage.

Figure 4. Problem and representative sites in subwatershed 709- the Lower St. Mary’s River.

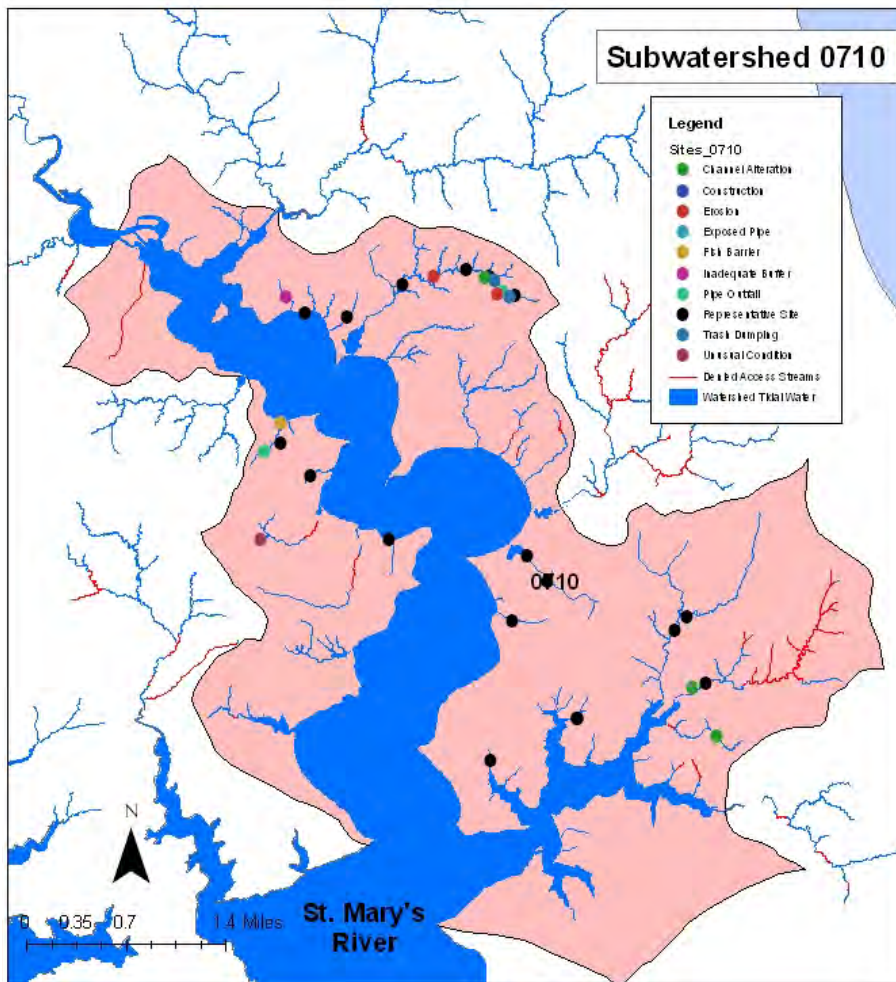
There were 13 problem sites and 20 representative sites in subwatershed 710. The problems were clustered primarily in a small unnamed stream that flows into Martin Cove in the northern part of the subwatershed. The problem sites there were mostly channel alteration (1), erosion (3) and trash dumping (2). The fact that most of these problems are concentrated leads us to the conclusion that they may be readily correctable.

Figure 5. Problem and representative sites in the Middle St. Mary's River (710).

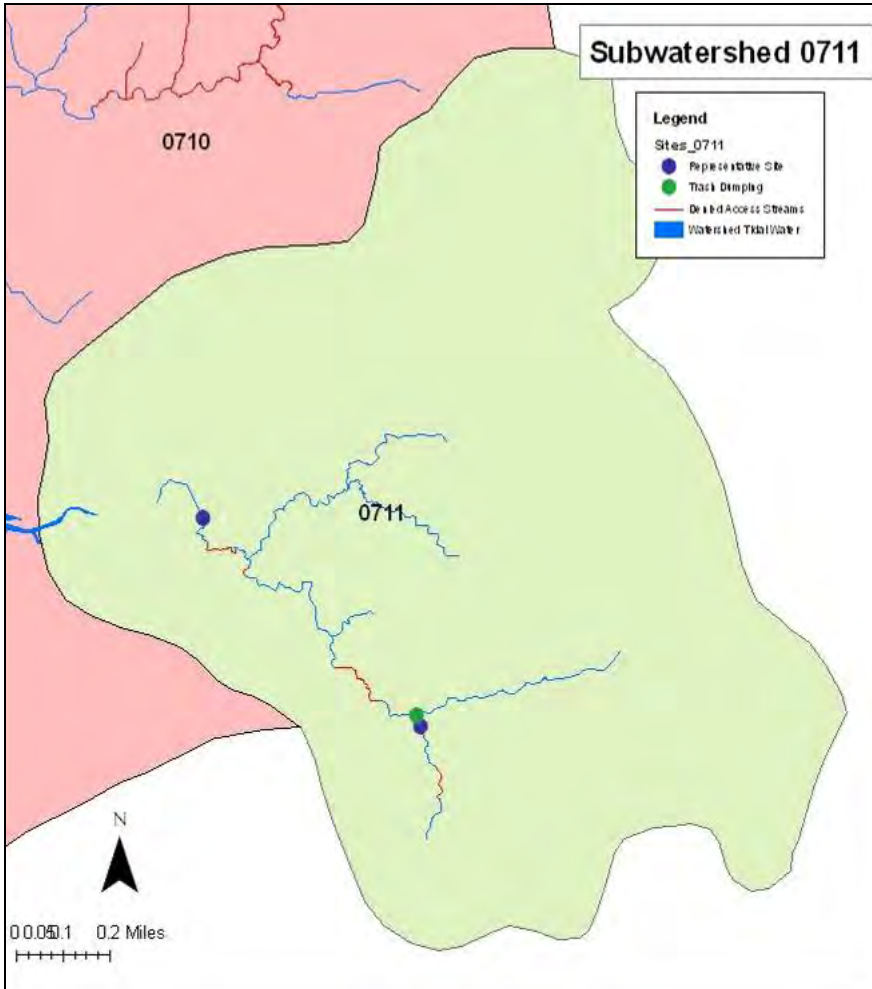
Figure 6. Problem and representative sites in subwatershed 711- Church Creek.

There were only one trash dumping site in this subwatershed and two representative sites were noted. Of all the subwatersheds, Church Creek seemed to have the fewest problems, but it is a very small watershed.

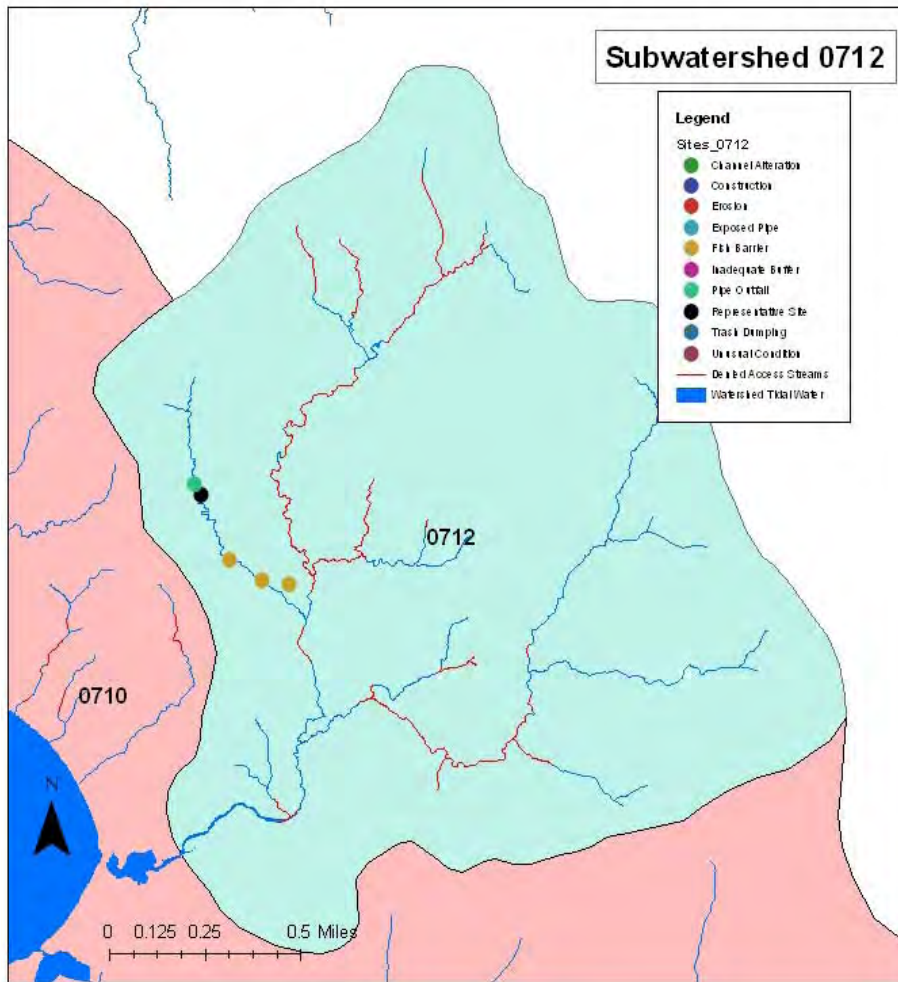
Figure 7. Problem and representative sites in subwatershed 712- Fishermans Creek.

limited, either by land owner denial or by posting, that it is difficult to draw conclusions about this subwatershed. We know that the streams that enter Fishermans Creek and discharge into the St. Mary's River carry very heavy sediment loads, as the tidal river is extremely murky following heavy precipitation events and spates.

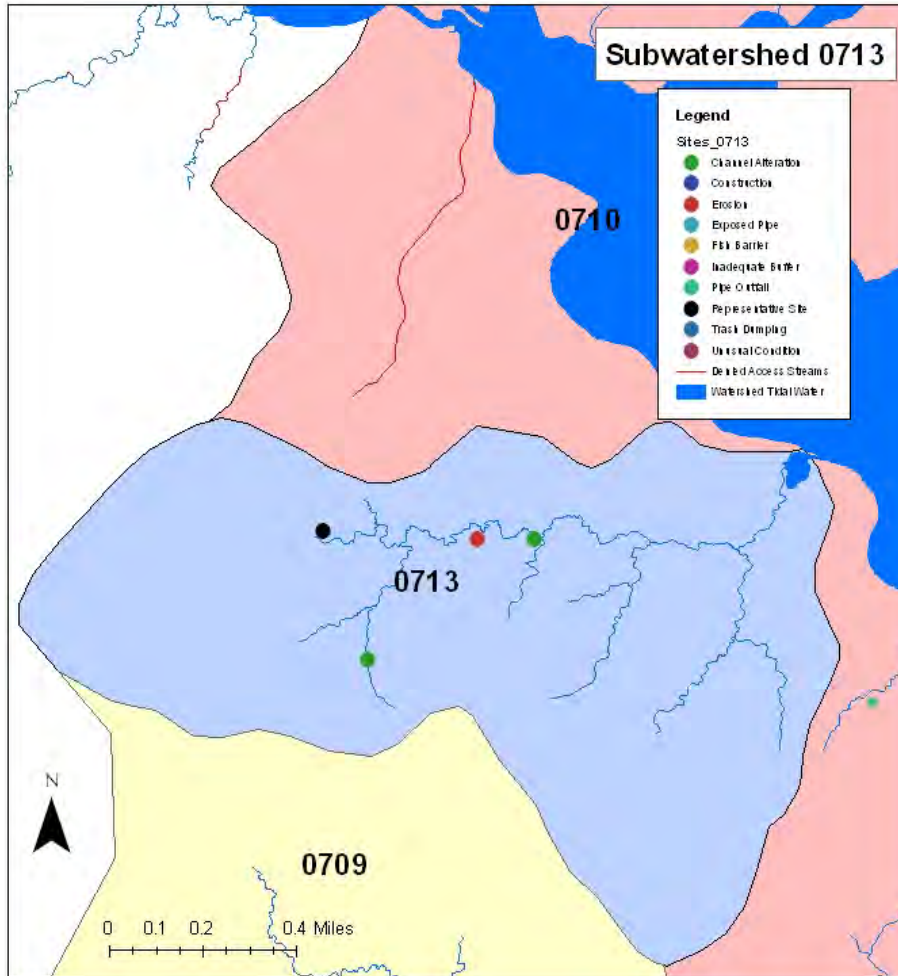
Figure 8. Problem and representative sites in subwatershed 713- Craney Creek

Yet, Craney Creek has only 3 problem sites (2 channel alterations and 1 erosion site) and we included a single representative site. For the most part the subwatershed's streams are in relatively good condition, but additional build out in the development may further impact Craney Creek.

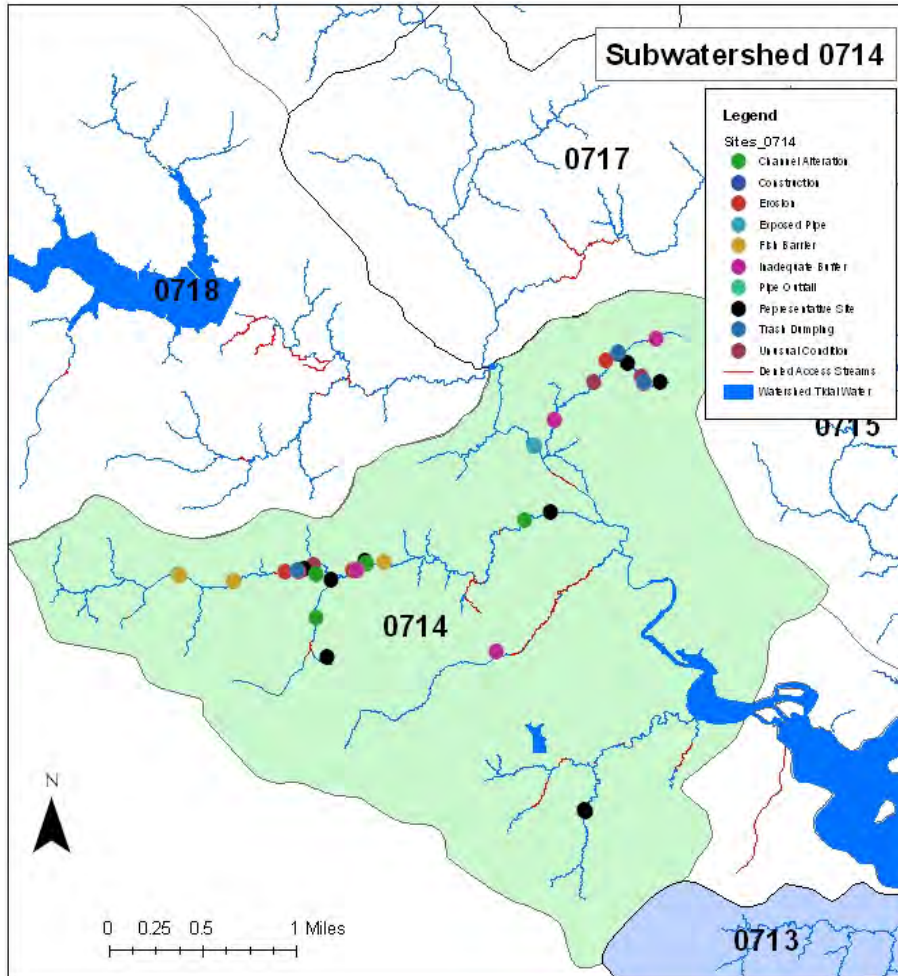
Figure 9. Problem and representative sites in subwatershed 714 - Johns Creek.

Yet, other subwatersheds with equivalent percentages of river miles (subwatersheds 710 and 716) had substantially fewer problems compared to Johns Creek. Channel alterations (6 sites) and erosion (7 sites) predominated, but there were also strong instances of trash dumping and inadequate buffers (5 sites each). Johns Creek had the most unusual conditions (4 sites) and instances of trash dumping of any subwatershed. It is fairly clear that this subwatershed is the most impacted of all those studied, and that it might be the most likely candidate for restoration actions.

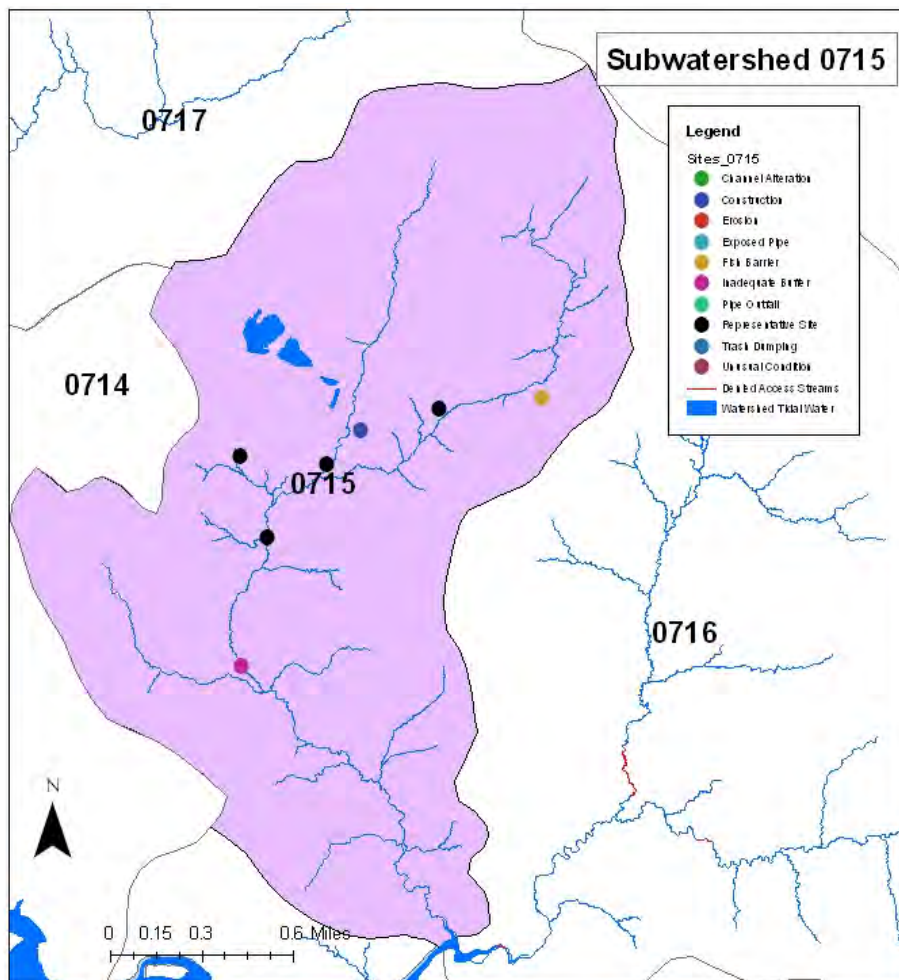
Figure 10. Problem and representative sites in subwatershed 715 – Hilton Run.

The subwatershed is relatively small with only 7.3% of the total watershed stream miles (Figure 10). Its headwaters are located in the Lexington Park Development District, but we found no major problems there during our stream characterization. Only 3 problems were noted, one construction site, one inadequate buffer, and one fish barrier. Here is substantial beaver activity in the central part of the subwatershed.

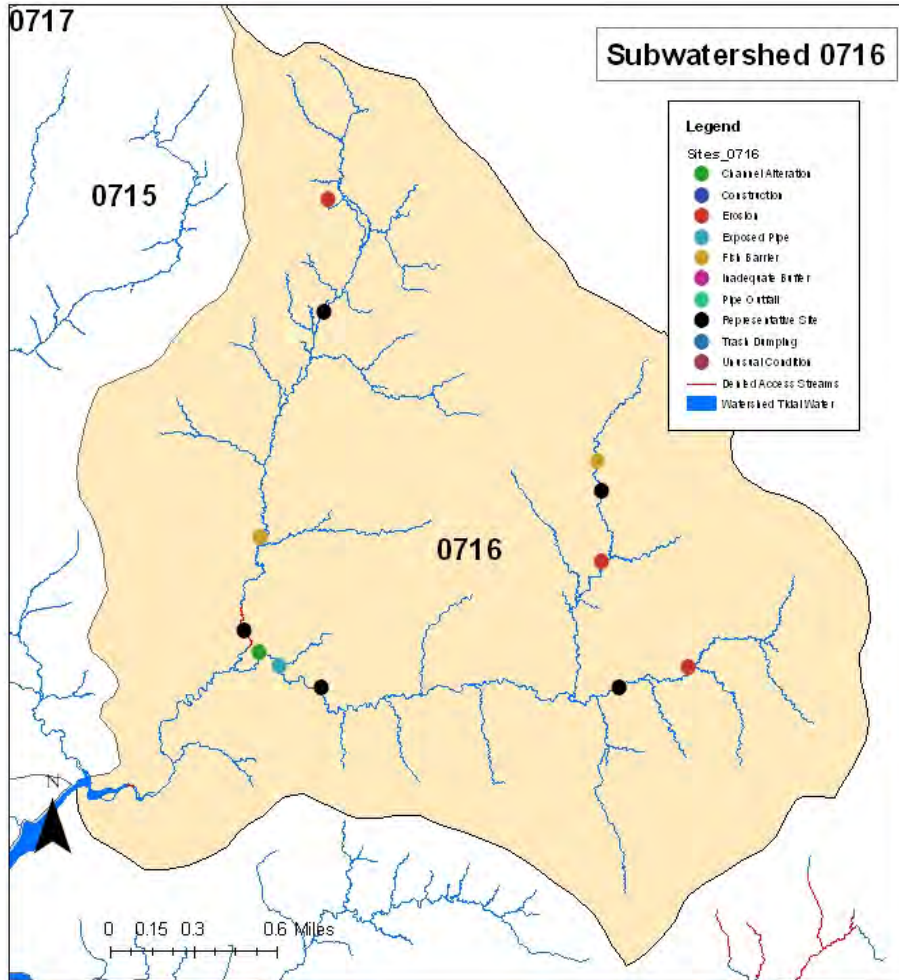
Figure 11. Problem and representative sites in subwatershed 716 – Pembroke Run

Pembroke Run has two major branches (Figure 11). The northern branch flows from the development district while the eastern branch flows through a mix of land uses, but primarily single family dwellings of moderate density. The primary problem in the subwatershed is erosion with 3 problem sites, followed by fish barriers (2) and one each of channel alteration, exposed pipe, and a construction site.

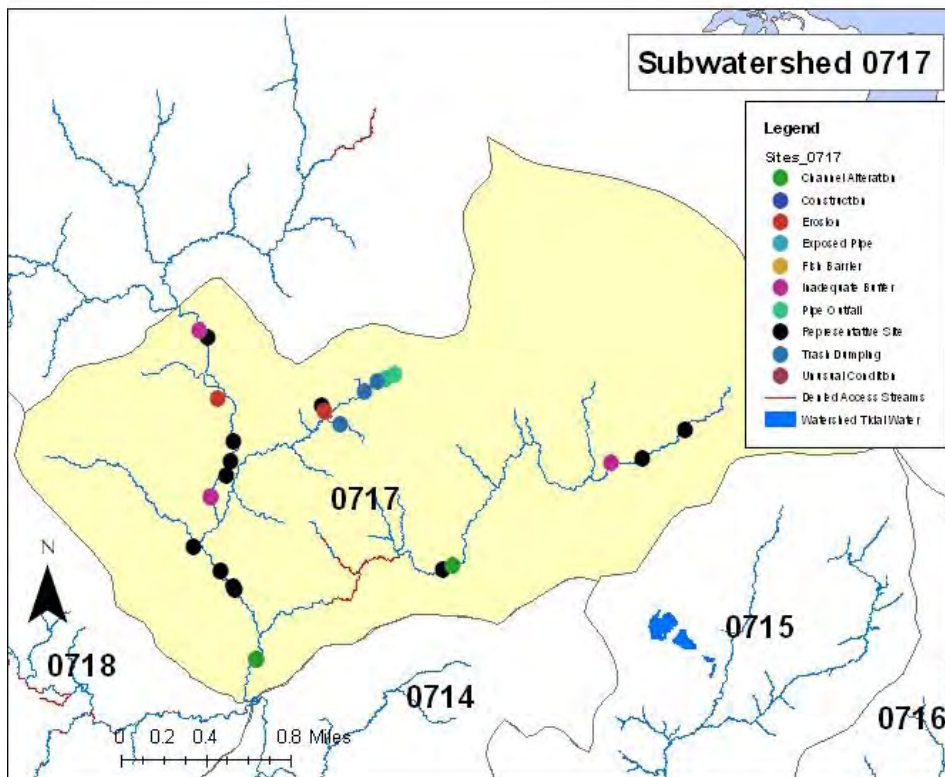
Figure 12. Problem and representative sites in subwatershed 717 – Eastern Branch.

problems found in the Eastern branch were 3 erosion sites and 3 inadequate buffers. There were also 2 each pipe outfalls, channel alteration, and trash dumping sites. Most of these were isolated in a small first order tributary in the northern tributary of Eastern Branch.

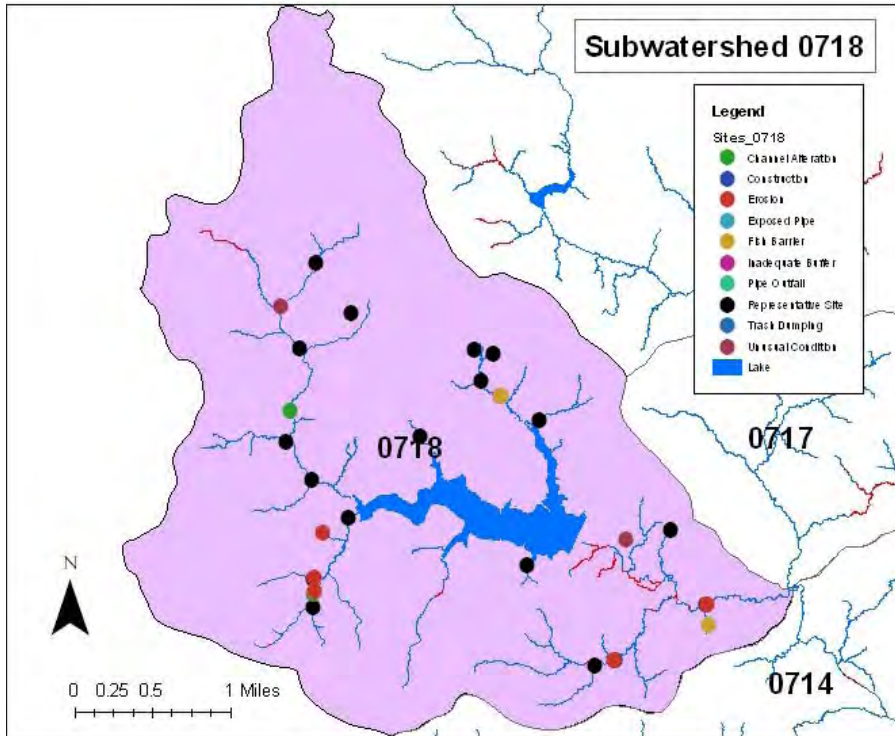
Figure 13. Problem and representative sites in subwatershed 718 – Western Branch.

There were slightly more representative sites (18) than problem sites (13) in this subwatershed, and this indicated to us that the Western Branch was relatively undisturbed. Both representative and problem sites were dispersed across the subwatershed (Figure 13). Erosion (6 sites) and fish passage barriers (3 sites) were the primary problems noted by the field teams. But there were also 2 channel alterations and 2 unusual conditions noted in this subwatershed.

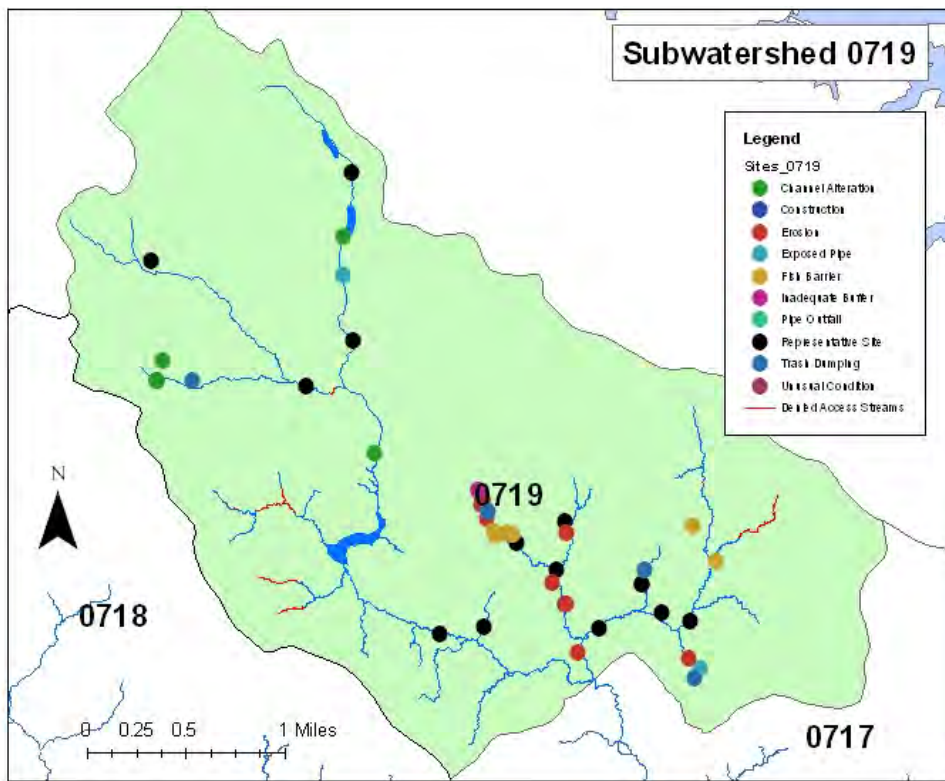
Figure 14. Problem and representative sites in subwatershed 719 – Upper St. Mary's River.

The Upper St. Mary's River has many (27) problems and was second only to subwatershed 714, Johns Creek. This was anticipated as this is by far the fastest urbanizing area in the watershed and the county. Commercial and many types of housing density are leading the development and impervious surface development is increasing a very fast rate in this subwatershed. Problems were concentrated in the southeastern portion of the subwatershed, and others (mostly stream channel alterations and exposed pipes) were located in the northwestern part of the subwatershed (Figure 14). There were many (7) erosion sites and fish migration barriers (6) and well as trash dumping (5 sites) all within 1 mile of each other. Clearly, this was the largest concentration of

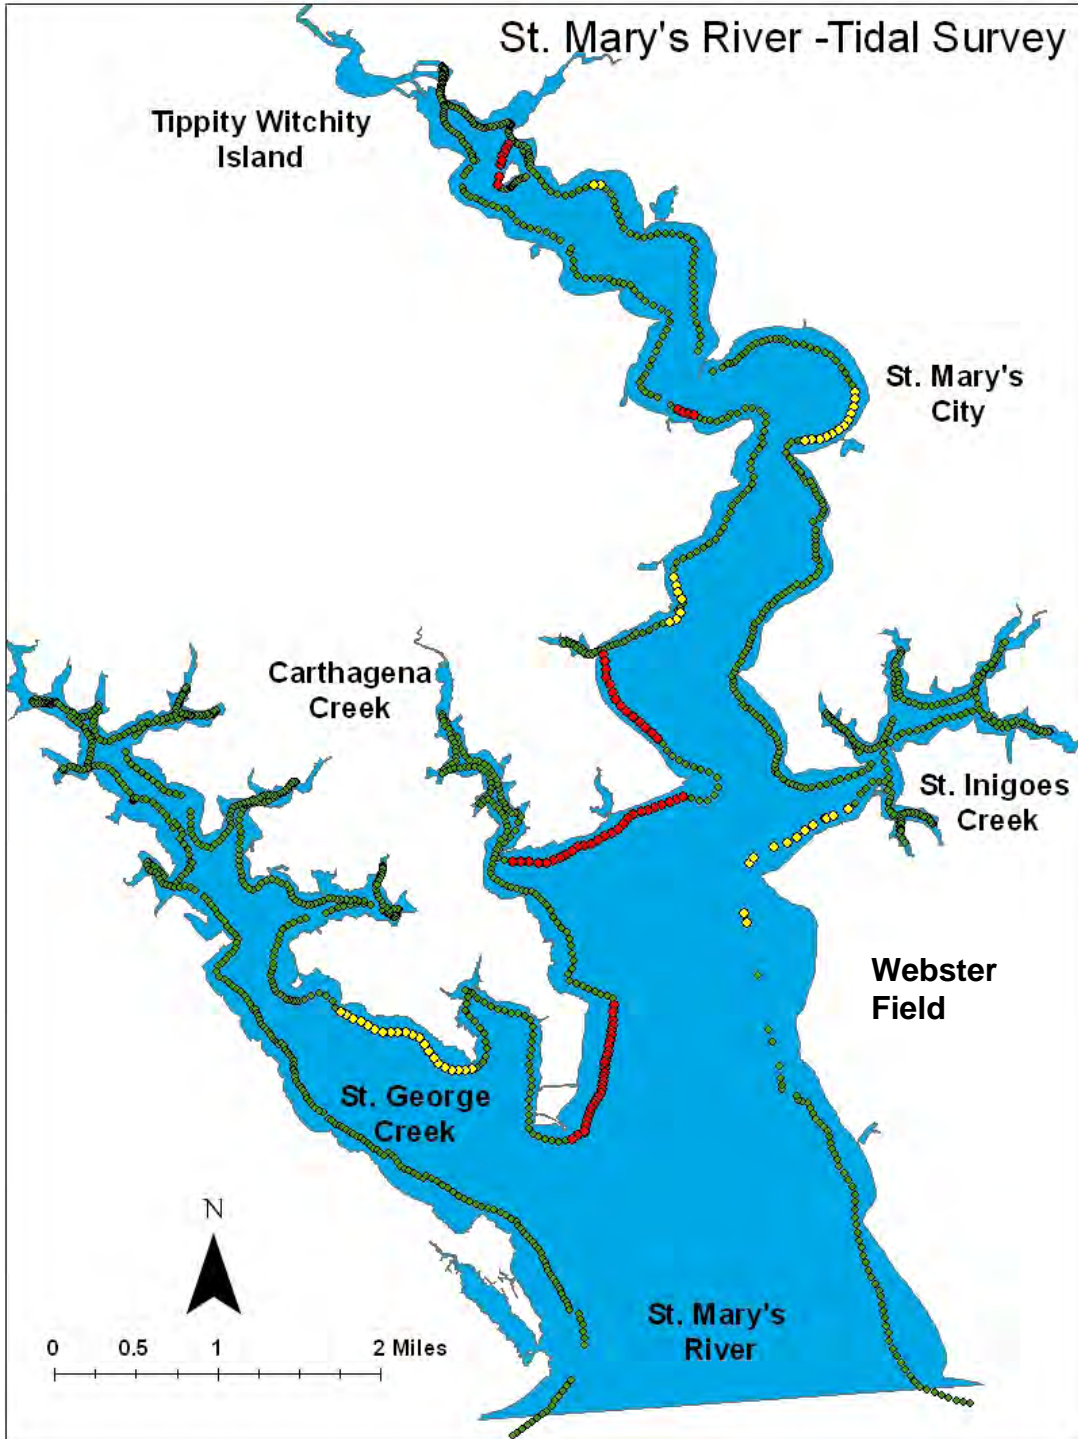
The most severe erosion site on the river is located on the western shore across from Chancellor's Point. At this site, an inadequate buffer has resulted in the erosion of a bank

Figure 23. Tidal shoreline of the St. Mary's River with an assessment of shoreline stability. Green markers indicate stable shoreline, red markers show shoreline erosion sites, and yellow markers show shoreline segments without correspond to geo-referenced photographs of the shoreline.

approximately 4 meters high and several hundred meters long (Images 623-636). A similar problem may be seen around the point to the south, where a bank approximately 2
