# St. Mary's River Stream Corridor Assessment and Tidal Shoreline Survey

**Robert W. Paul, Ph.D.**  
**Department of Biology**  
**St. Mary's College of Maryland**  
**St. Mary's City, MD 20686**  
**In Partnership with**  
**St. Mary's River Watershed Association, Inc.**  
**PO Box 94, St. Mary's City, MD 20686**

**September 30, 2008**

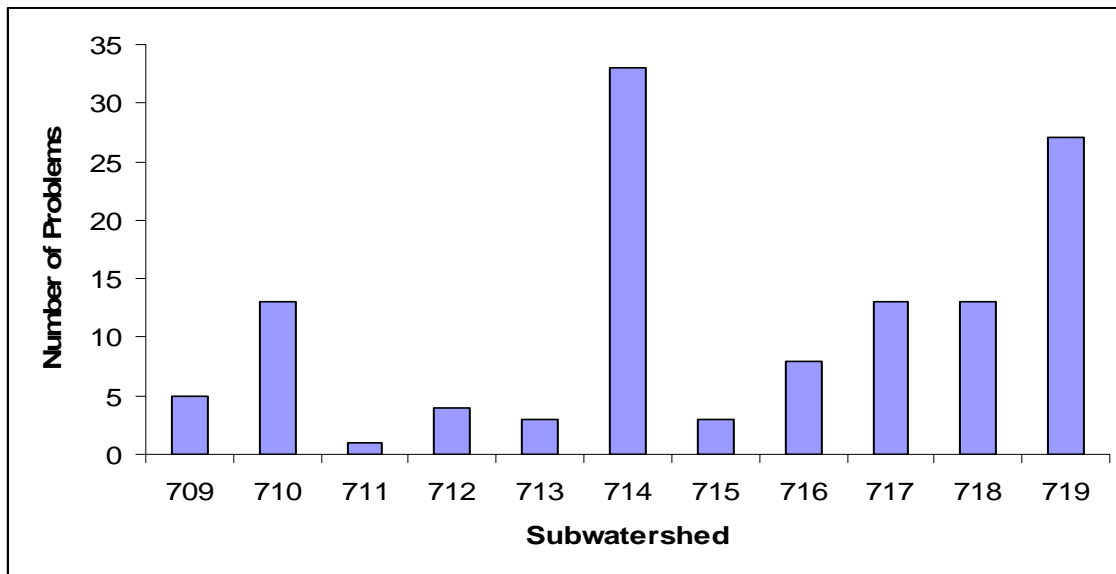
Figure 3. The number of problems identified in each subwatershed.

All of the identified problems were not spread evenly between the subwatersheds (Figure 2). Subwatersheds 714 and 719 had significantly more problems than any other watershed followed by subwatersheds 717, 718, and 710 with an intermediate number. Subwatersheds 709, 711, 712, 713, 715, and 716 had very few problems. The overall frequencies of problems by subwatershed are shown in Figure 3.

Analysis of problem types by subwatershed (Table 3, Figure 3) showed, not surprisingly, that the larger watersheds (those with more than 10% of the total stream miles in the subwatershed) also had the greatest number of representative and problem sites. However, some problem sites may have been underestimated in subwatersheds such as 712, Fishermans Creek, where such a large proportion of the streams could not be accessed. A quarter of the pipe outfalls were found in Subwatersheds 710 and 717.

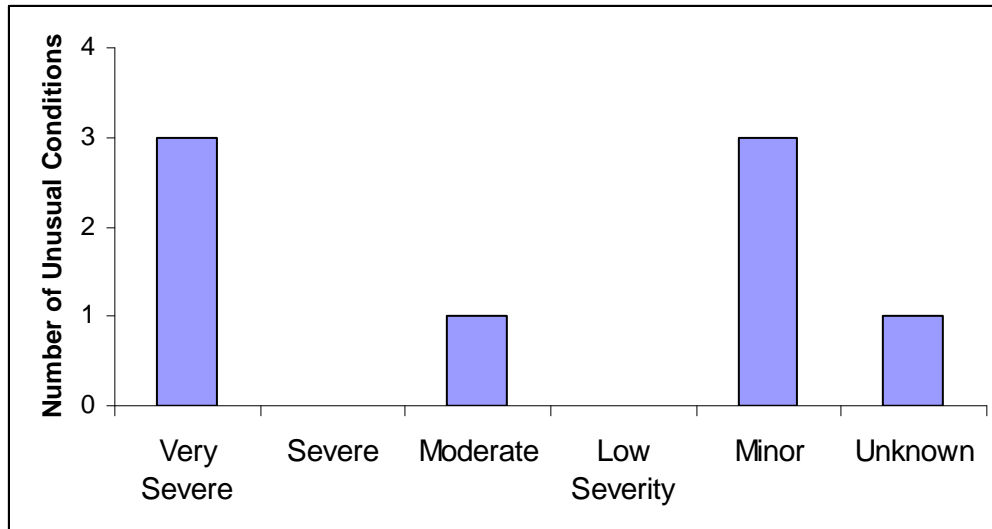
Figure 15. The frequency of unusual conditions with each severity ranking.

The survey teams recorded unusual conditions when a problem that did not fit into any other categories was identified. In the St. Mary's River watershed there were a total of eight unusual conditions. This included two man made ponds, two power lines in the stream, one ATV track, one beaver dam, an underground tributary, and a road that was built right through a stream. The severity rankings for these sites were relatively arbitrary and are pending further investigation (Figure 15).

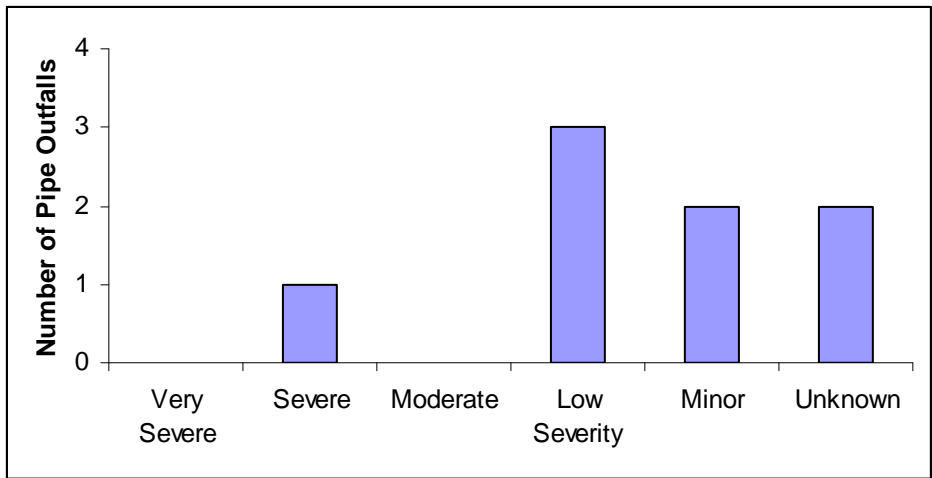
Figure 16. The frequency of pipes with each severity ranking.

In the St. Mary's River survey, special attention was paid to pipes that had discharges. Half of the eight discovered pipe outfalls had discharges. One of the pipes had a brown discharge was also accompanied by a musky odor. It was assumed that most of these pipes were part of a storm water system, but further scrutiny by a professional is required to determine their real origins. Figure 16 shows the severity distribution of all the pipe outfalls. The unknown severities were a result of the survey team not knowing if the discharge was a significant problem.

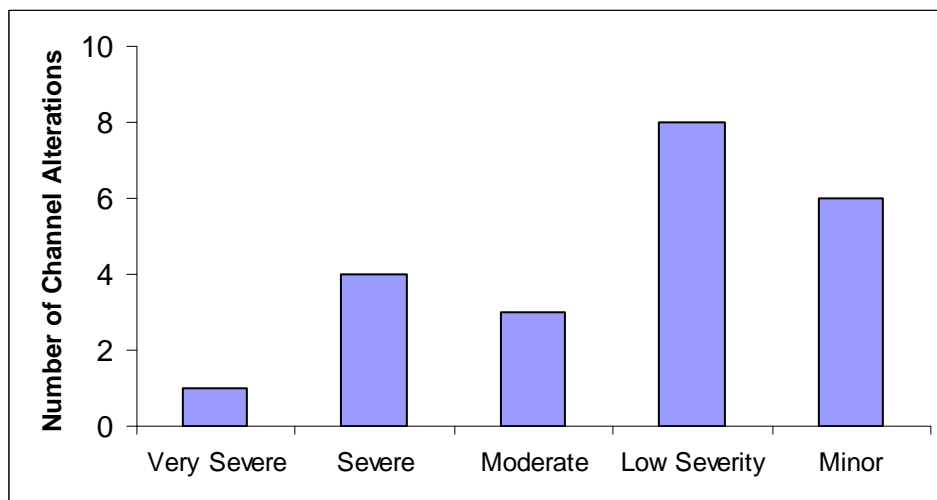
Figure 17. The frequency of channelization with each severity ranking.

The survey teams found a total of 22 channel alteration sites in the St. Mary's River watershed. Most of these alterations manifested themselves as concrete, but there was also rip-rap, metal pipes, plastic, steel pipes, and PVC pipes. All but one of these exhibited perennial flow and most had sediment deposition. In only four cases was there vegetation in the channel. The vast majority of channelizations were found below road crossings, and there was a wide range of severity throughout the watershed (Figure 17).

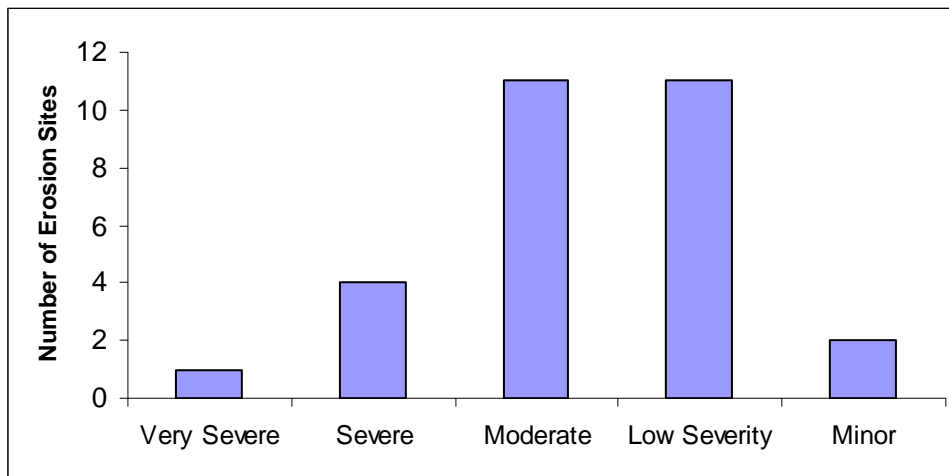
Figure 18. The frequency of erosion sites with each severity ranking.

Since erosion is a natural process, it is also incredibly common. This is reflected in the 29 erosion sites that were found in the survey, and these outnumber all other problem types (Figure 18). In reality, almost every foot of stream exhibited signs of erosion, but in many cases the erosion was very minor and not worth mention. Almost all of these problems were caused by a bend in the course of the stream at a steep slope. There were also four erosion sites caused by a fragile bank, one caused by channelization, and one where the cause was unknown. The land use on all but two banks was forests with the two exceptions being a lawn. None of the erosion sites were a threat to any infrastructures.

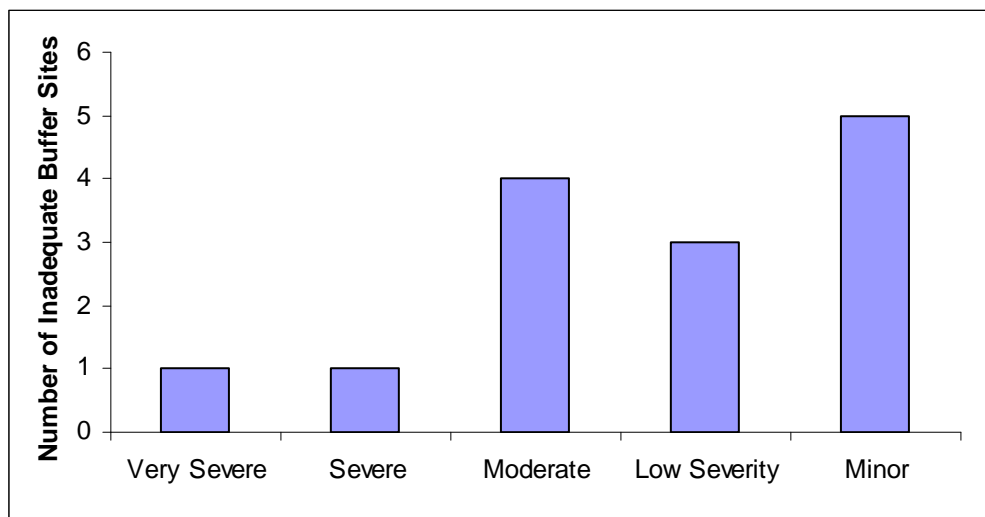
Figure 19. The frequency of inadequate buffers with each severity ranking.

This survey identified 14 sites that had inadequate buffers. None of these were recently established, and only one had livestock present. In most instances the streams lacked a buffer on both the left and right banks. The land use was variable and included forests, pastures, power lines, small trees, lawns, wetlands, and crop fields. As with the other problem types, most of the inadequate buffer sites were of minor or moderate severity (Figure 19).

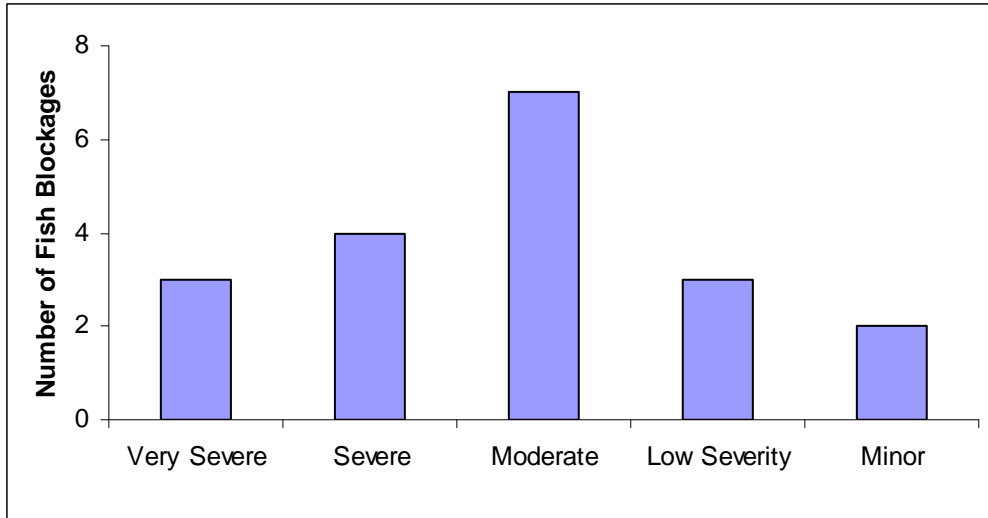
Figure 20. The frequency of fish blockages with each severity ranking.

swim through it. In this survey nine were too high, five were too fast, and five were too shallow. Additionally, if the water is moving too fast the fish may not be able to build up enough power to make it upstream. The severity of these blockages created a bell curve with most sites of moderate severity and few very severe or minor (Figure 20).

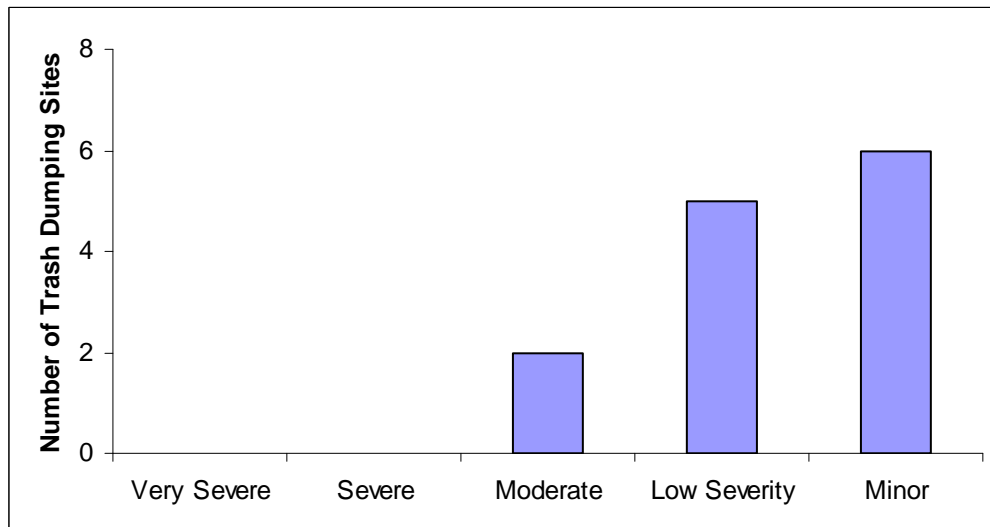
Figure 21. The frequency of trash dumping sites with each severity ranking.

Trash dumping sites include both sites where there is a considerable amount of trash and sites that have the potential to collect a large amount of trash. This accumulation can either be due to nearby residential areas or storm drainage. In the SCA survey of the St. Mary's River watershed there were only moderate and minor trash dumping sites which made the severity rankings skewed to the right (Figure 21).
